Problem soils, Flux quadrangle, Tooele County, Utah.

COMPILED BY BILL D. BLACK
DRAFTED BY NOAH P. SNYDER

Utah Geological Survey
Open-File Report 318 PLATE 5B
1995

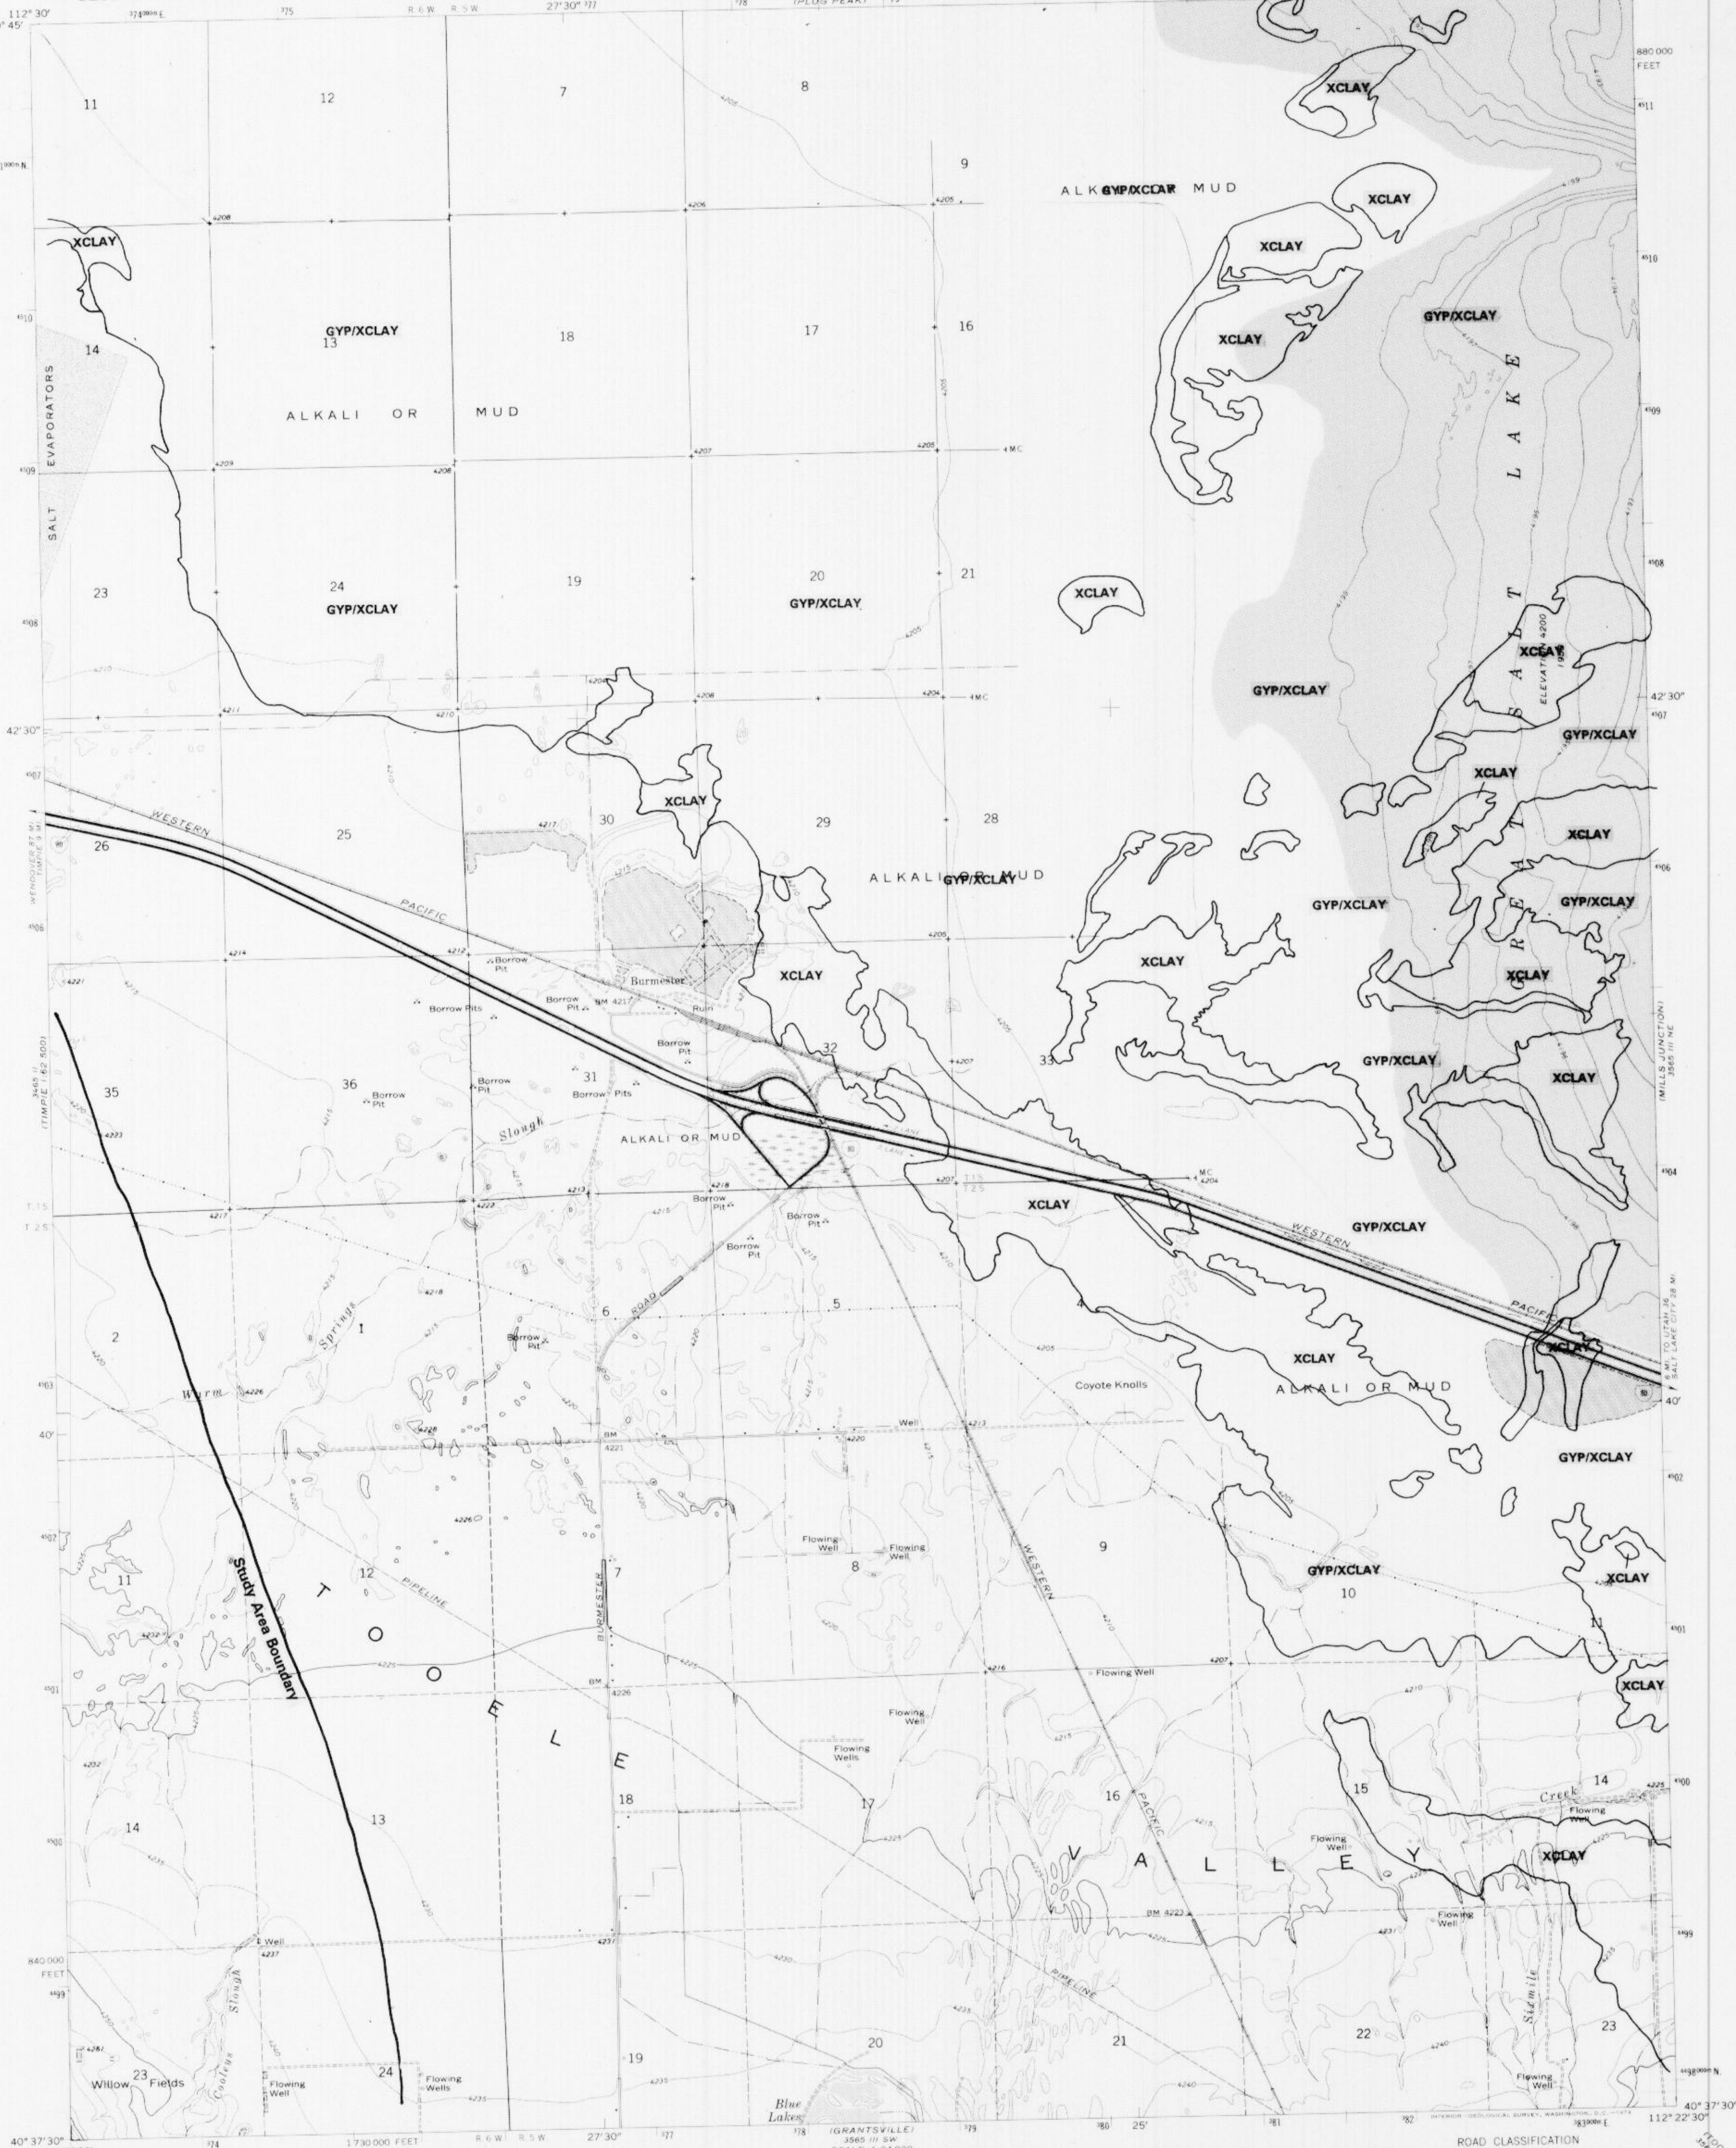
- XCLAY Possible expansive soil.
- GYP Possible gypsiferous soil.
- GYP/XCLAY Both possible gypsiferous and expansive soils.

Note: A standard soil investigation is recommended in all areas, including those where expansive and gypsiferous soils are not present (see table 1).
